# Guildford Street, Chertsey Heritage Assessment

**Client:** Runnymede Borough Council

**Date:** February 2024

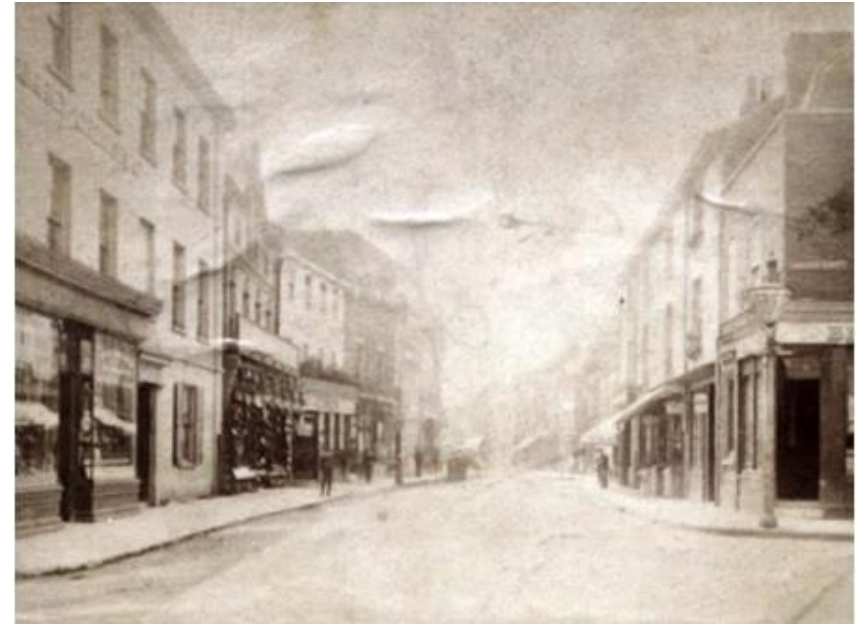
**Figure 2: Late-nineteenth century photograph showing wide junction of Guildford Street, London Street, and Windsor Street.**

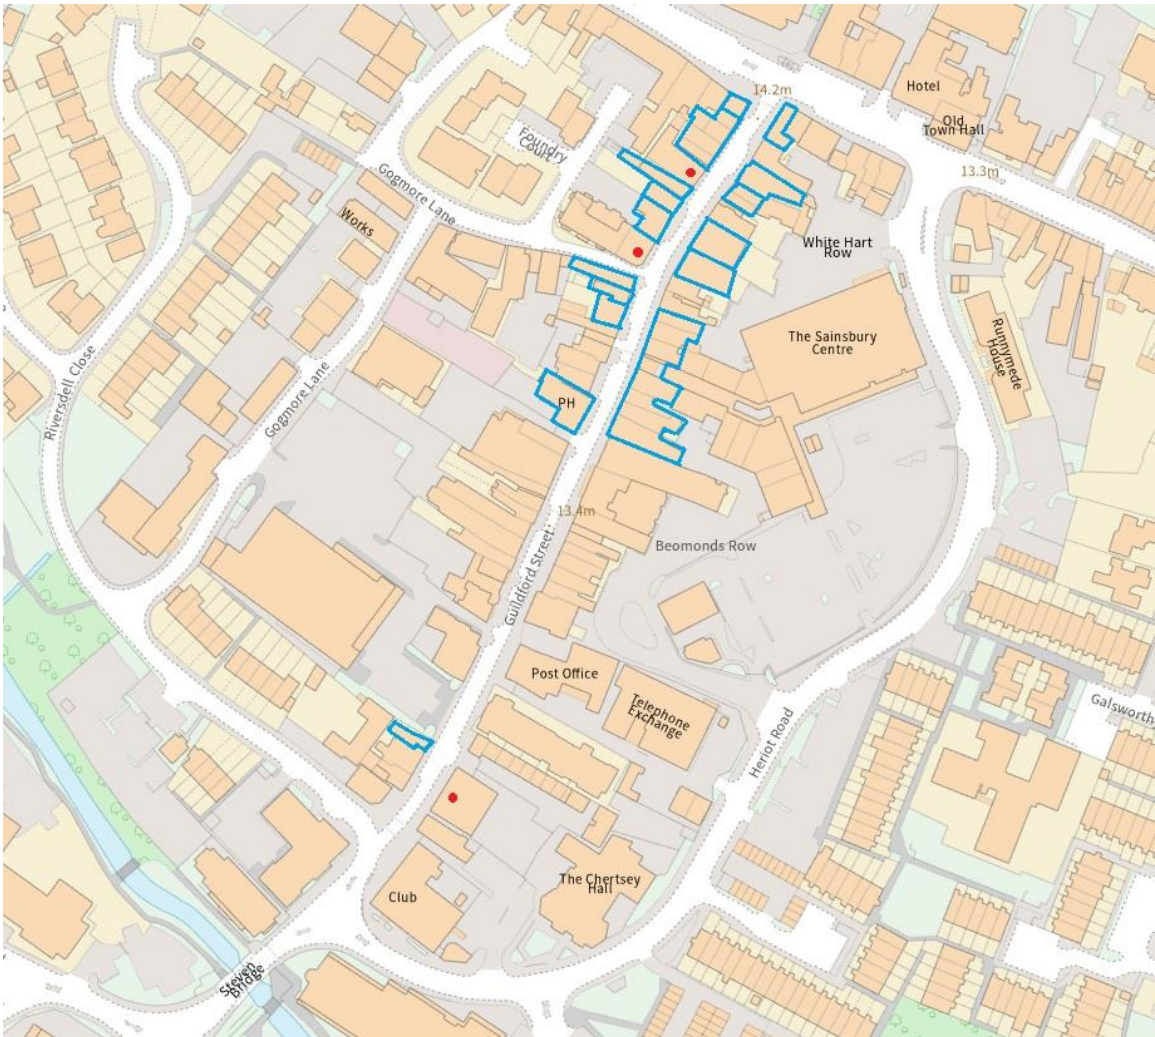
**Figure 4: Heritage Asset Map (designated heritage assets are edged in blue; non-designated heritage assets indicated by red circle)**

Guildford Street is located within the Chertsey Conservation Area and there are 18 statutorily listed buildings within the study area (Figure 4).

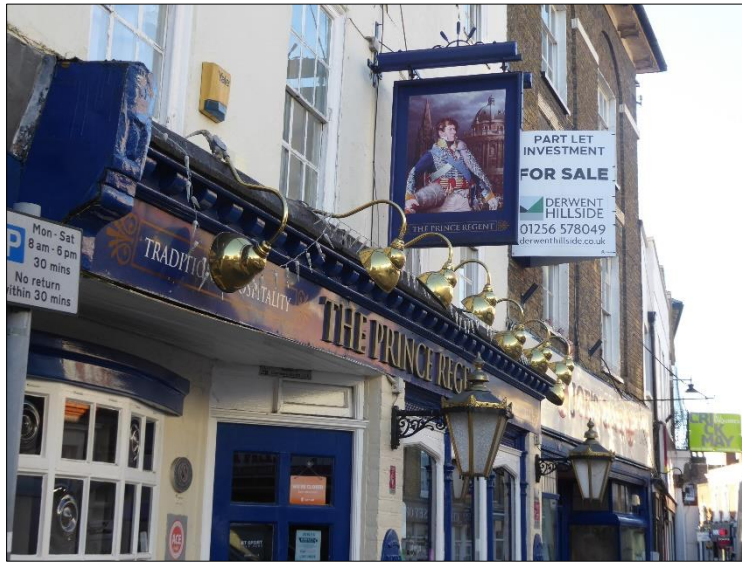
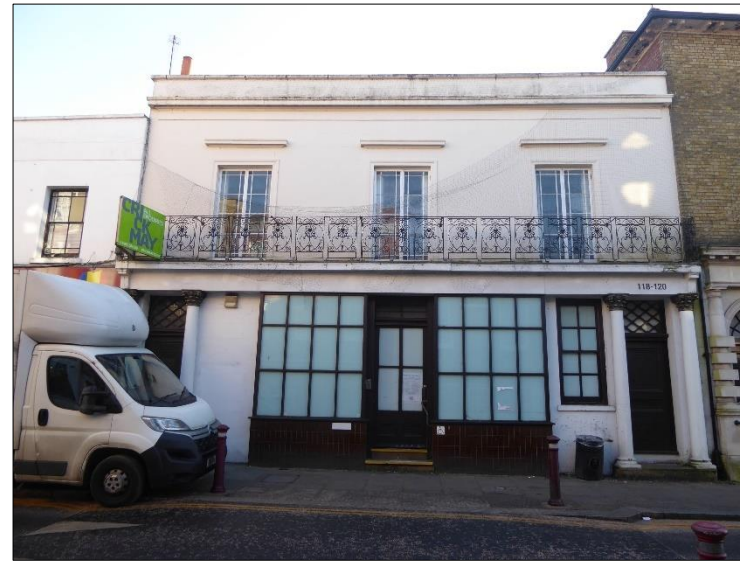
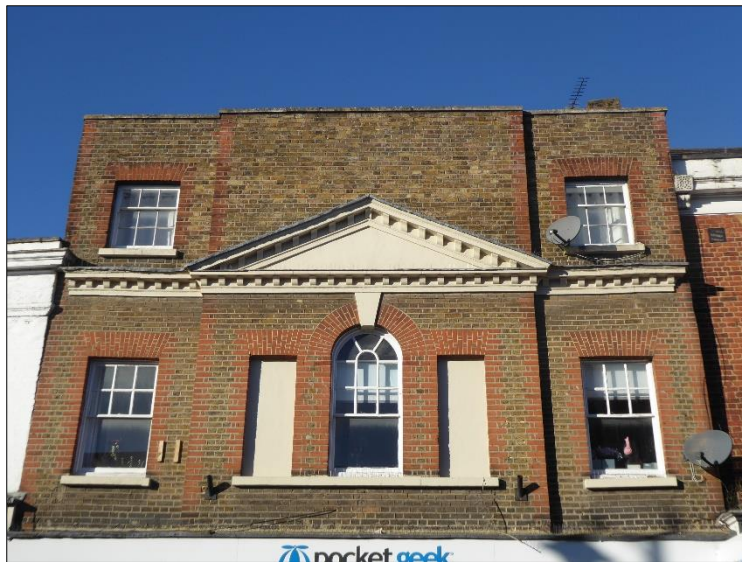
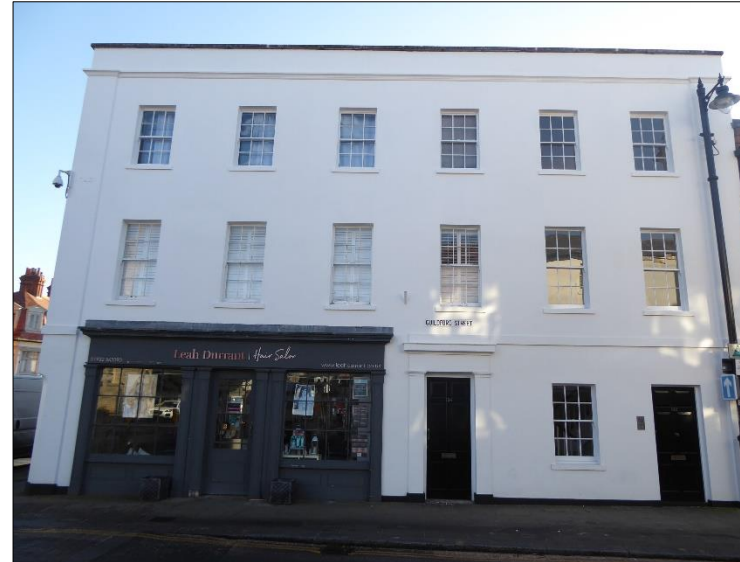
Figures 5-8  
(Clockwise from  
top left)

The Prince  
Regent; 118-120,  
Guildford Street;  
132-134, Guildford  
Street; 113,  
Guildford Street.

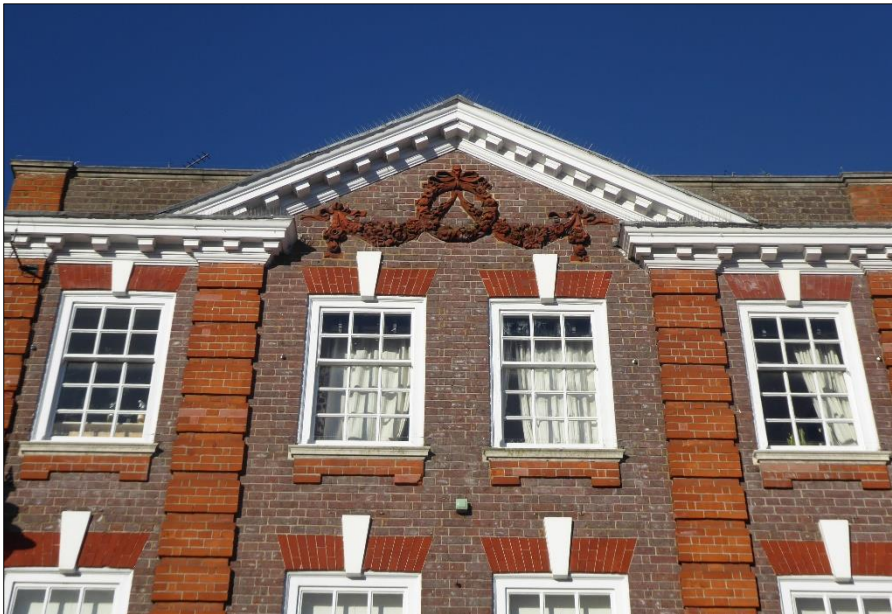
<b>NDHA</b>	<b>Local List Description</b>
<p>Barclays Bank</p> <p>(125 Guildford Street)</p>	<p><u>Reason(s) for Local Value</u></p> <p>Association: With C.G Miller. Illustration: Continues in original function as bank. Aesthetics: Landmark building with a grand and decorative Classical style</p> <p><u>Reason(s) for Standing Out in its Surroundings</u></p> <p>Rarity: Example of renaissance style in Chertsey</p>
<p>No. 119a Guildford Street</p>	<p><u>Reason(s) for Local Value</u></p> <p>Aesthetics: Contribution to Guildford Street due to its distinctive design and prominent corner position. Association: History of retail, specifically selling carpets and furnishings. Communal: Role in collective memory of the history of Chertsey's main retail street</p> <p><u>Reason(s) for Standing Out in its Surroundings</u></p> <p>Rarity / Local Identity and Distinctiveness: Distinctive architectural style</p>

Figure 9: Upper floors of locally listed 125, Guildford Street.

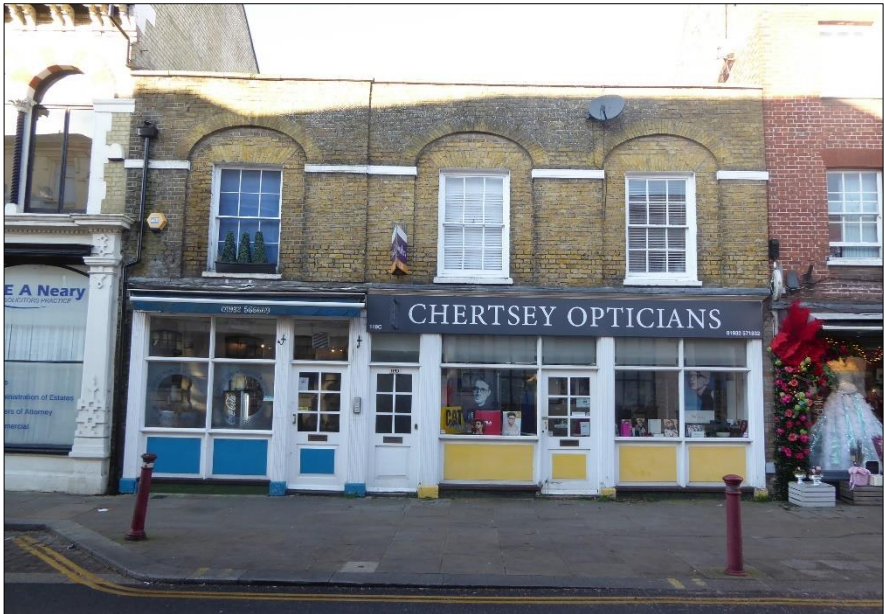
Figure 10: Locally listed 119, Guildford Street.

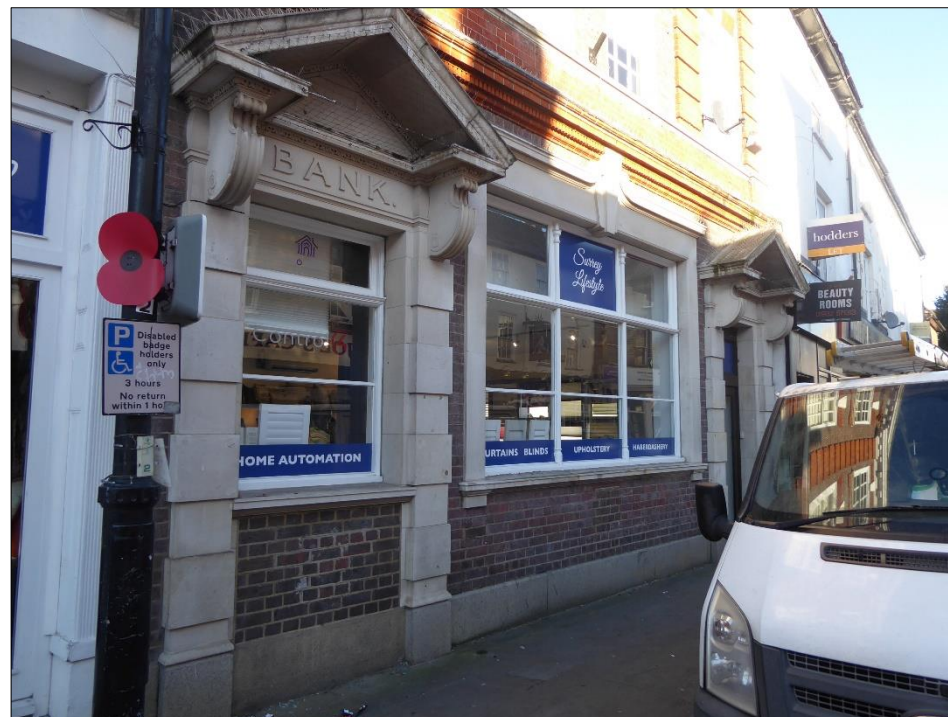
Figure 11: Stone cladding to 125, Guildford Street

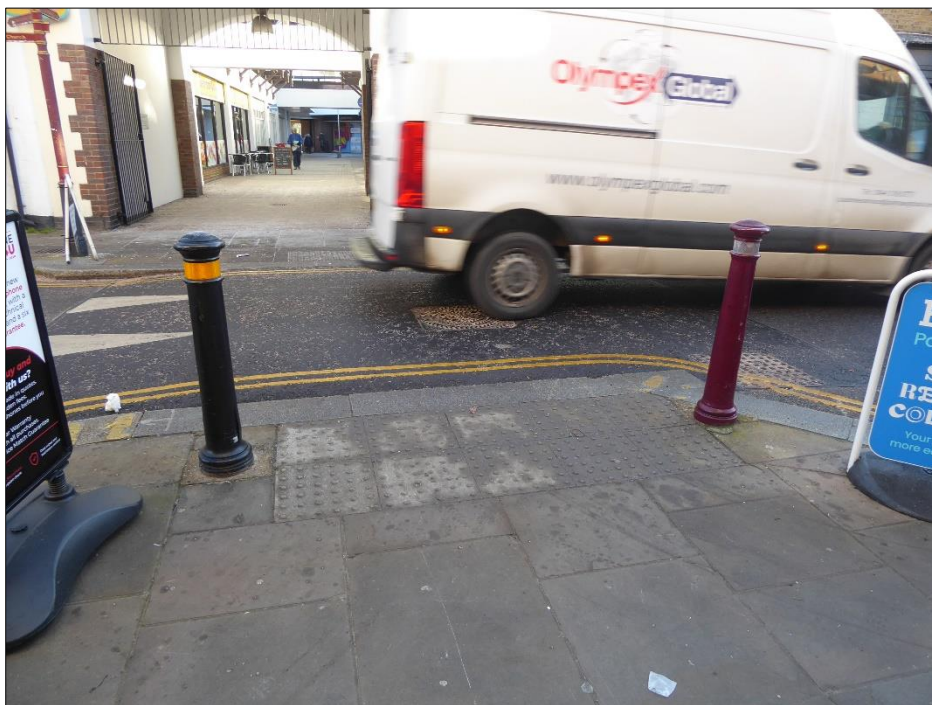
**Figure 12: Inconsistencies in the design and colour of street furniture add to the sense of visual clutter.**

Whilst some of the street furniture is well-designed to respond to the historic character of the street, much of it is poorly maintained and in need of repair, refurbishment, or replacement. The variance in style and colour also adds to the sense of clutter along the street. An abundance of A-boards, as well as commercial wheelie bins, also add additional clutter to the pavements, and reduce pedestrian movement.

The abundance, and variation, of street furniture is a detracting feature along Guildford Street. A programme of repair and maintenance, along with rationalisation would greatly reduce public realm clutter and enhance character and pedestrian experience. Adherence to a standard design code for street furniture would be beneficial.
